# South Kohala Stream Corridor Assessment Erosion Monitoring, and Recommendations

**Final Report  
September 2014**

Department of Land and Natural Resources  
Division of Aquatic Resources  
1151 Punchbowl St, Room 330  
Honolulu, HI 96813

**SUSTAINABLE RESOURCES GROUP INTN'L, INC.**

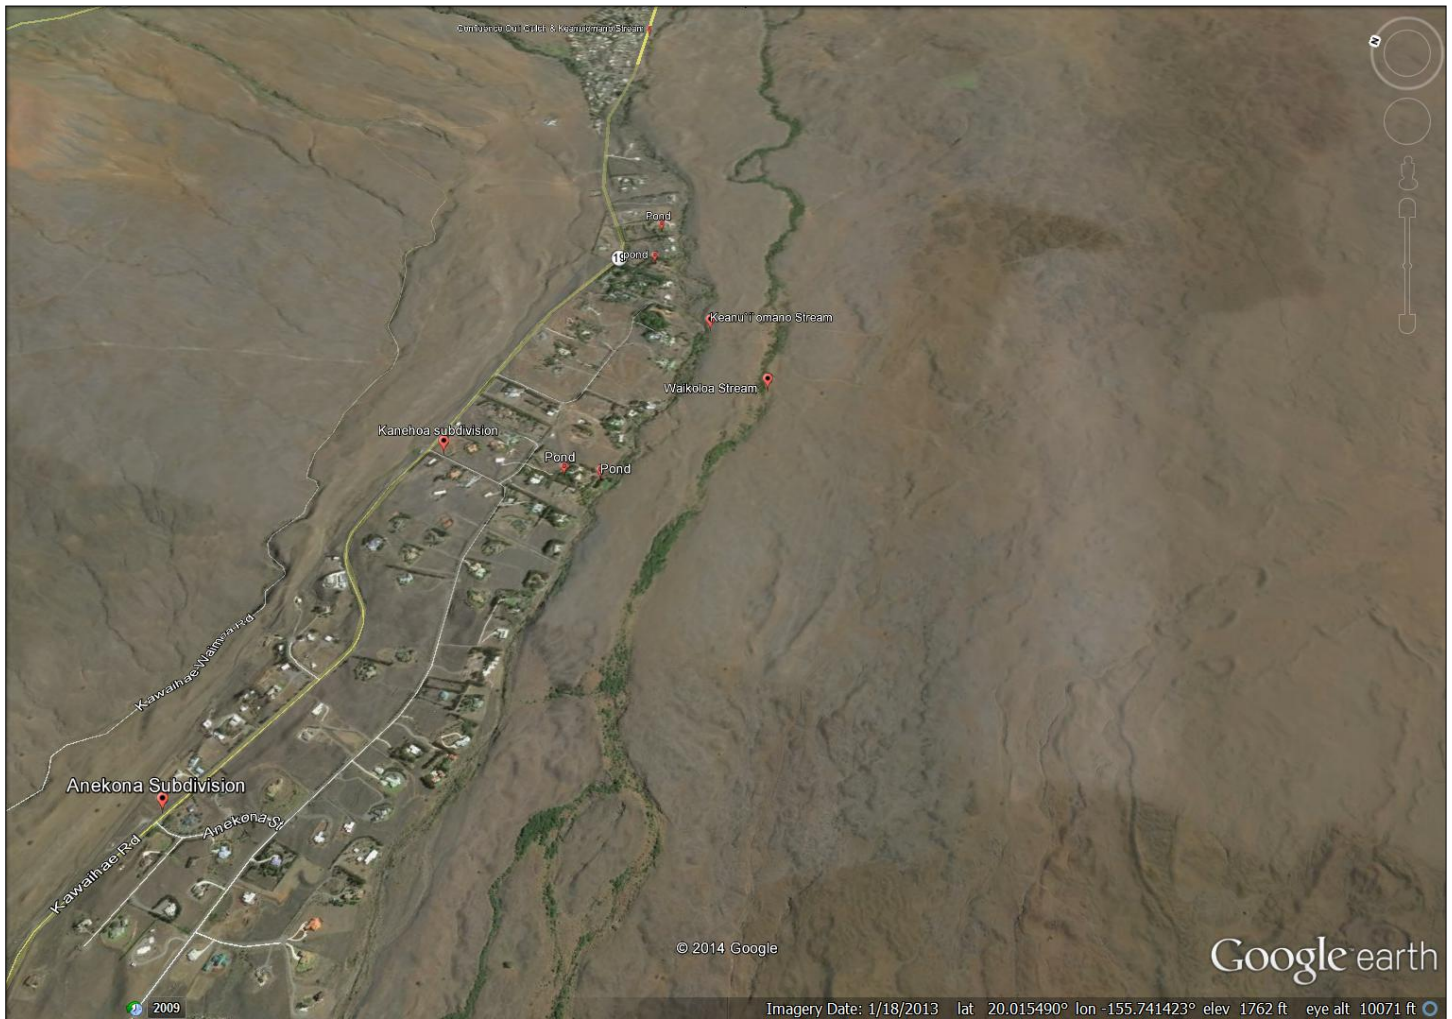
### Photo 11. Ponds

Four ponds adjacent to Keanu'i'iomanō Stream. The source of water for these ponds, which are located on private parcels, is assumed to be withdrawals from the stream.

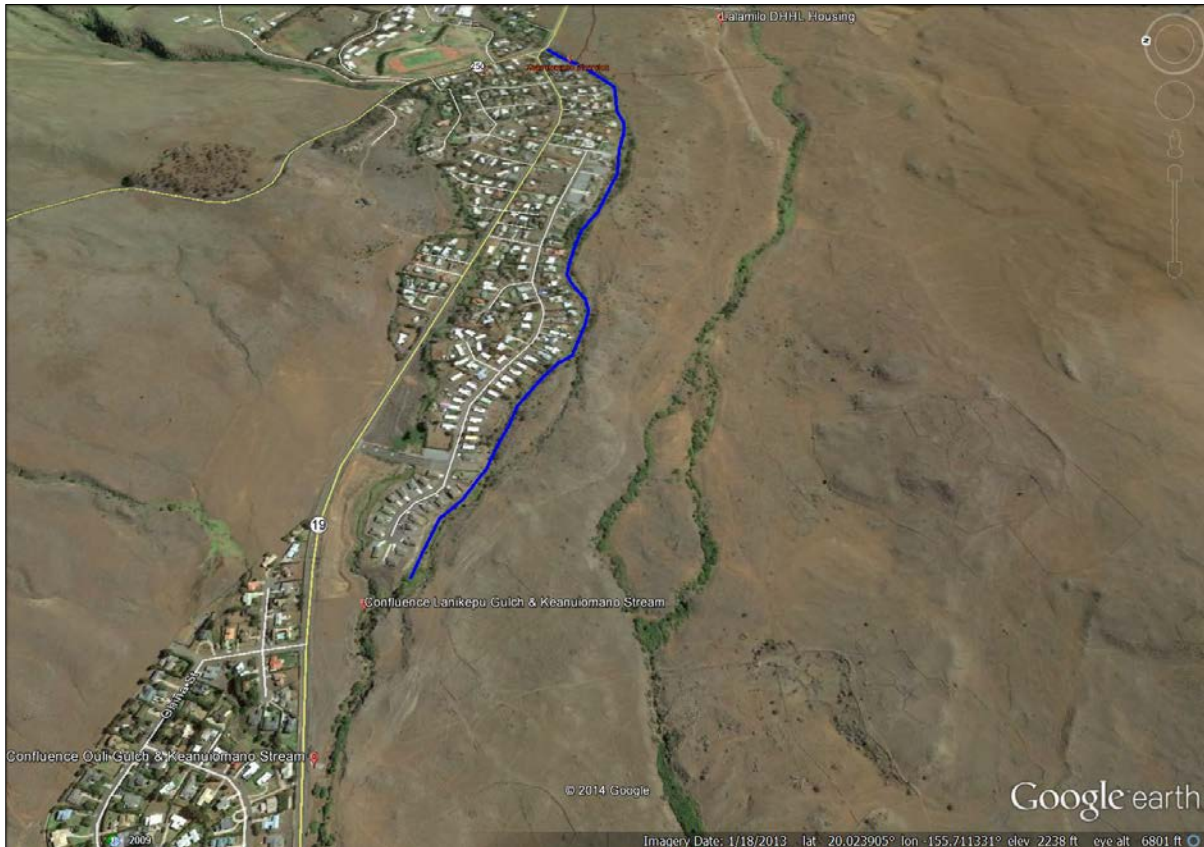
**Photo 12. Keanu'i'omanō Stream, nearby development**

Blue line depicts Keanu'i'omanō Stream; houses to the left and their OSDS close to stream.

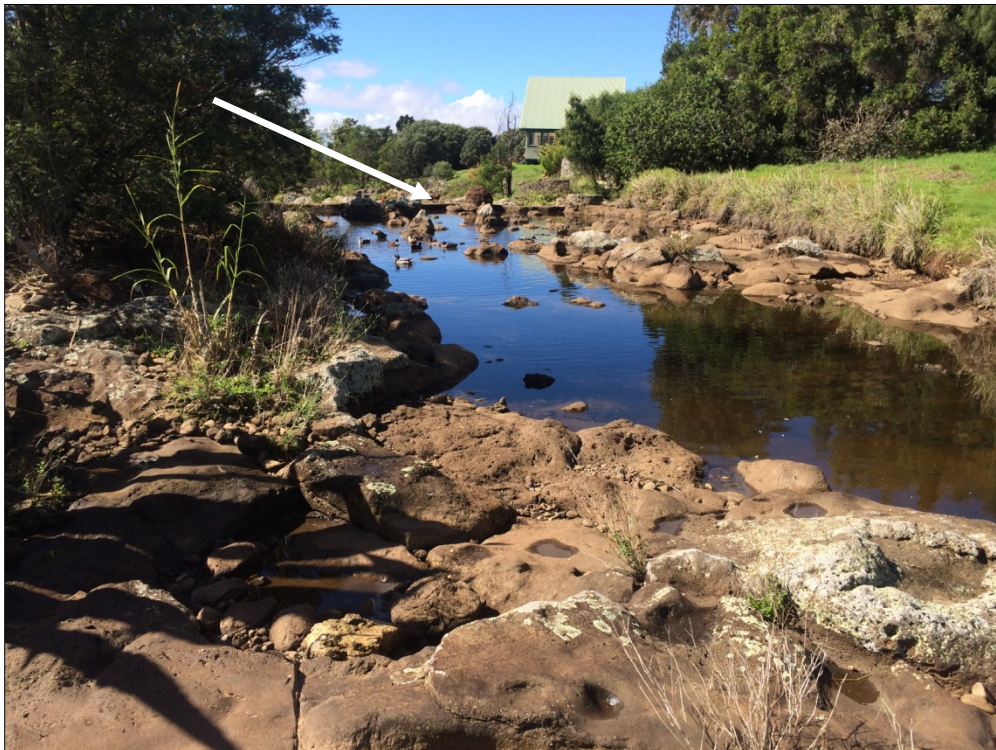
**Photo 13. Rock Dam on Keanu'i'omanō Stream**

Rock and mortar dam on stream near Waiaka Street.

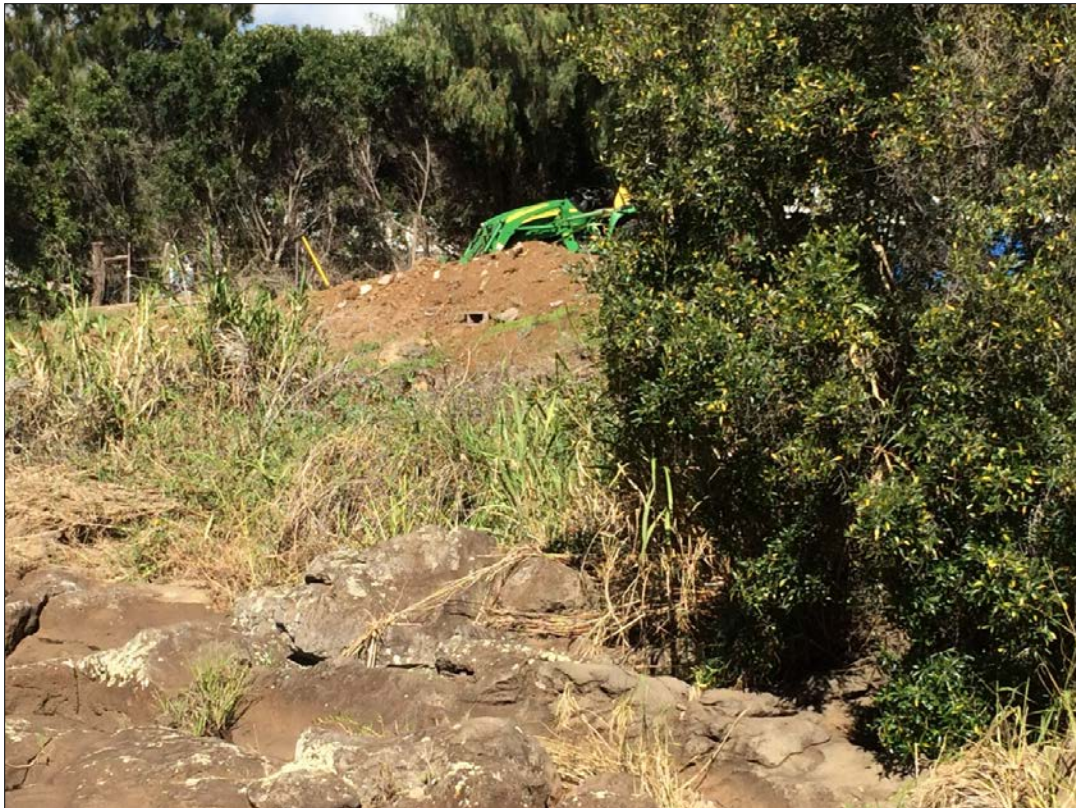
**Photo 15. Stream Encroachment**

Uncontained fill above Keanu'i'omanō Stream.

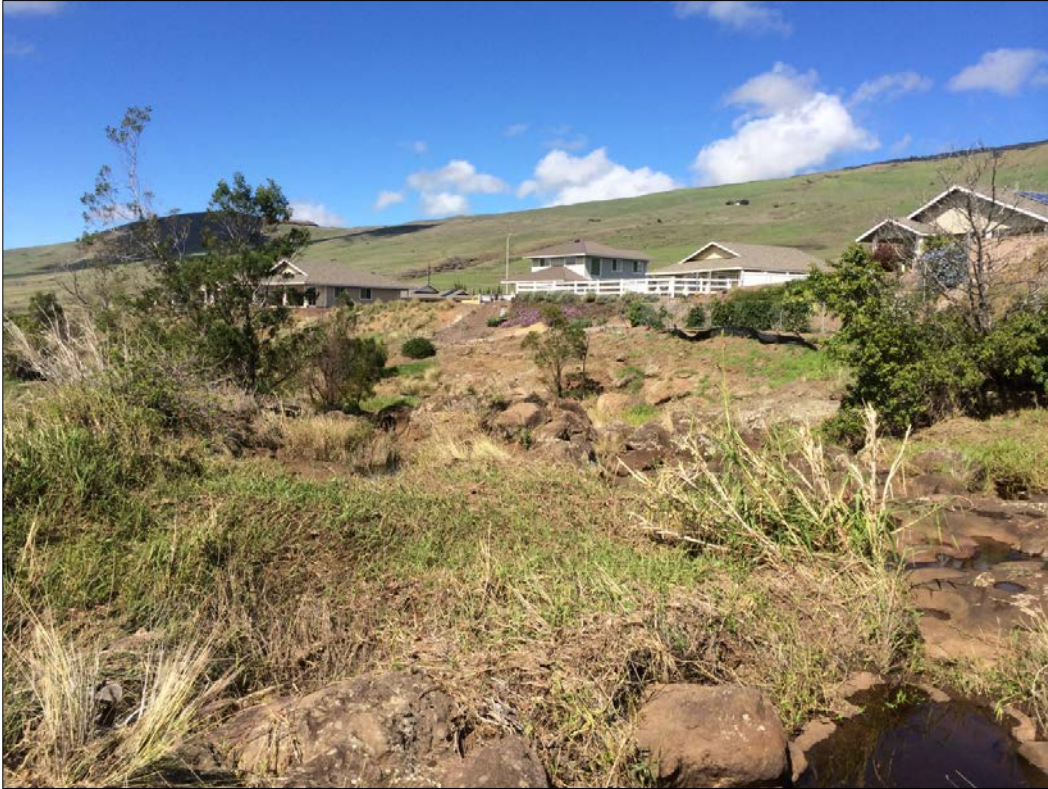
**Photo 16. Failing BMP along Stream**

Silt fence failing; fill material was observed in active channel.

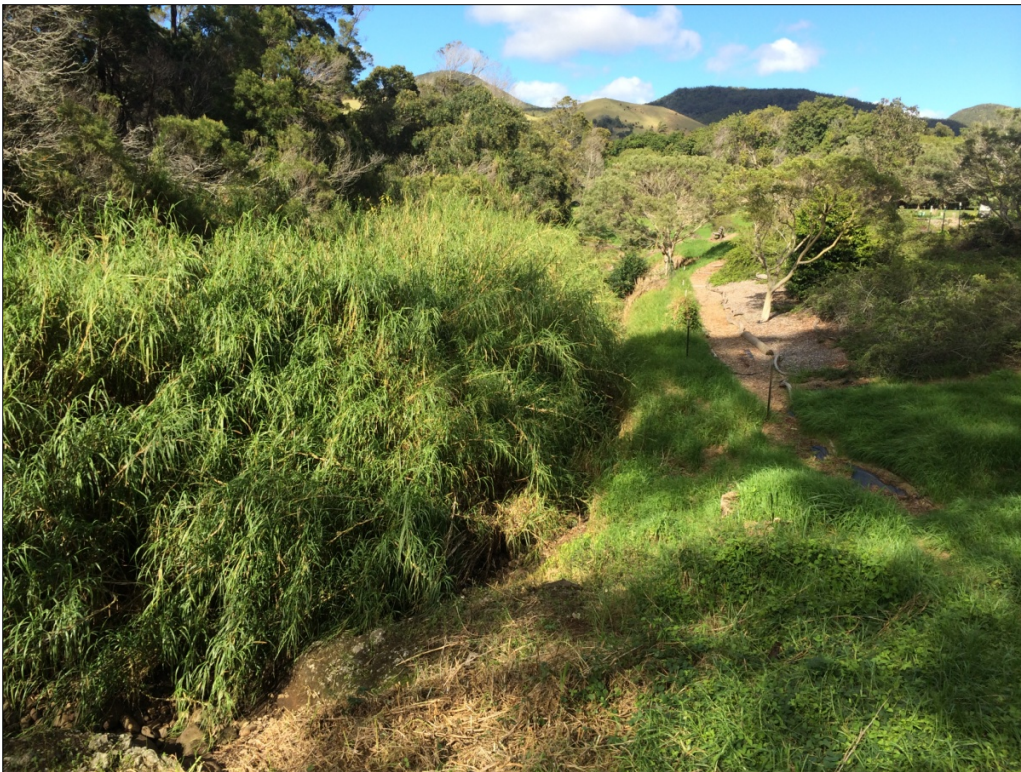
**Photo 17. Waikoloa Stream, channel blockage**

Section of Waikoloa Stream along trail below Waimea Nature Park.

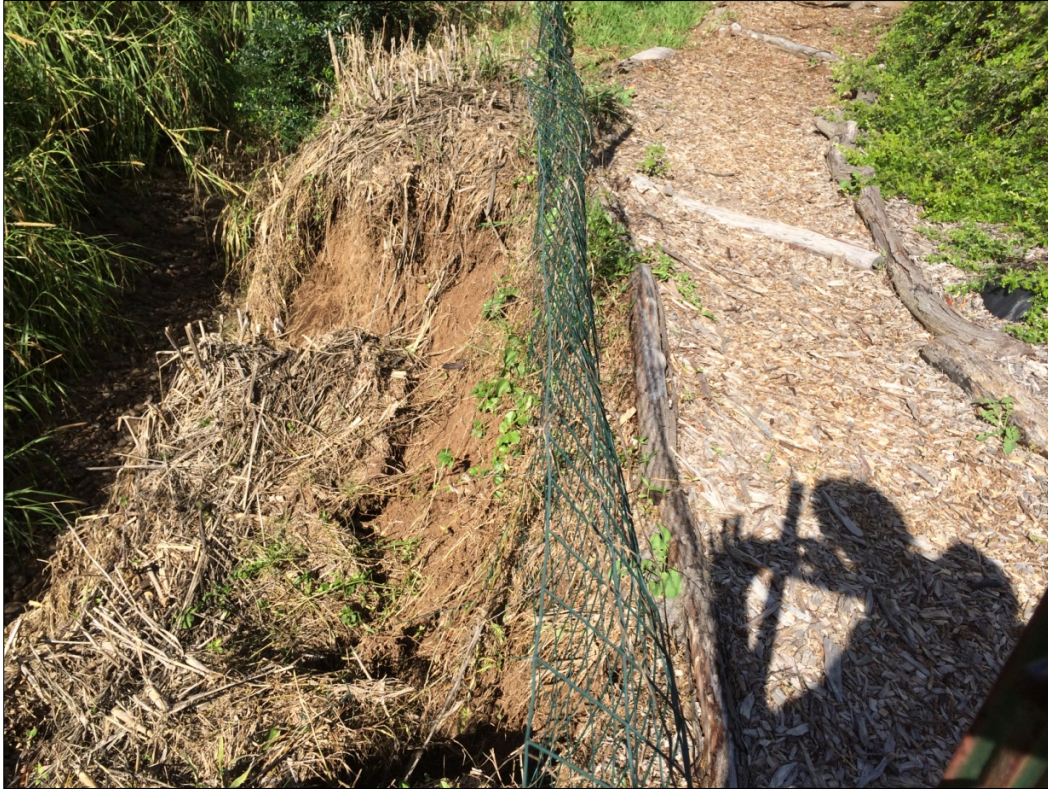
**Photo 18. Waikoloa Stream, failing stream bank**

Section of Waikoloa Stream bank within Waimea Nature Park.

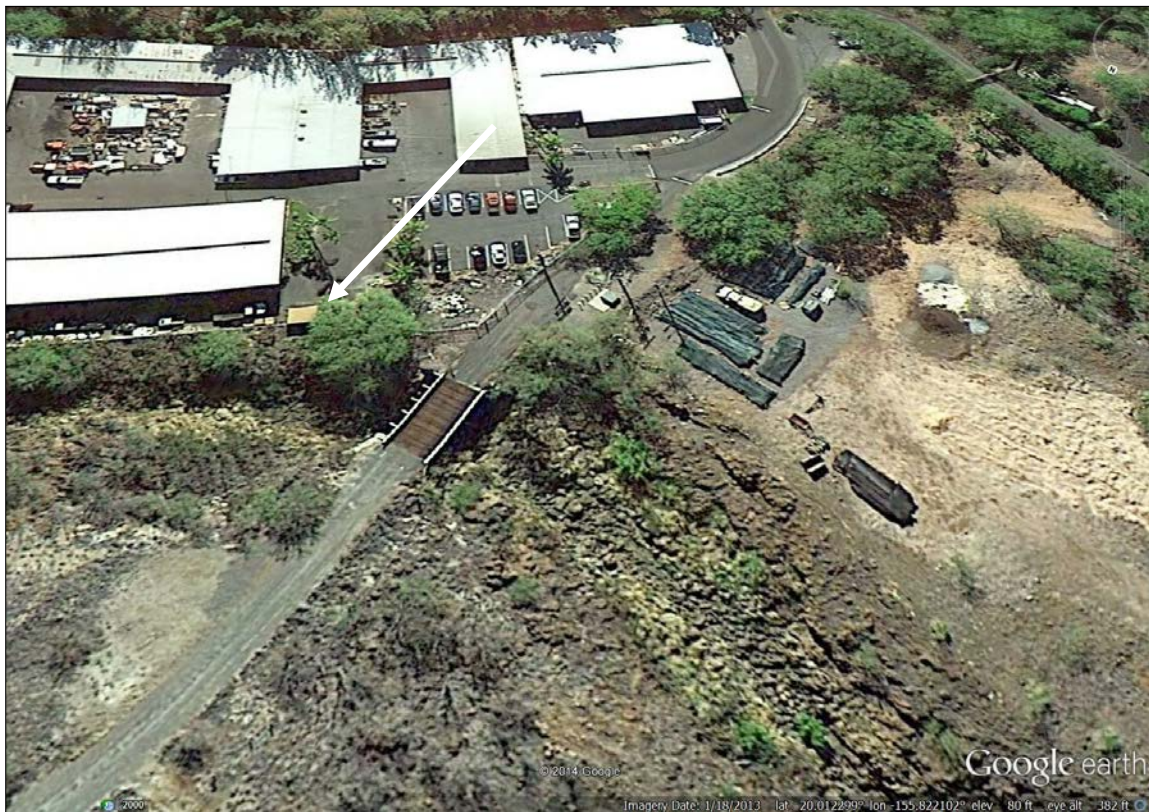
**Photo 4. 4PT, Maintenance yard runoff**

Edge of parking lot located on top of Wai'ula'ula Stream south bank.

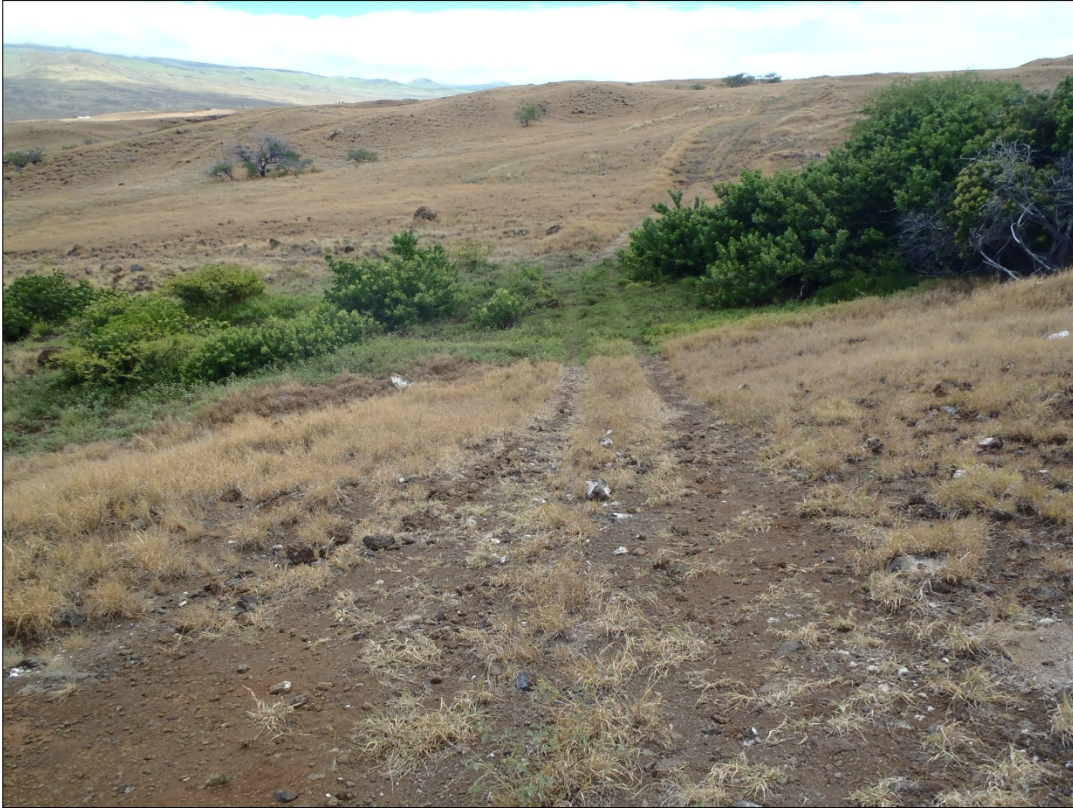
**Photo 7. 9PT, Dirt Road Crossing Channel**

Dirt road approach over southern branch of Waikoloa Stream, State Land

8PT	Sediment input at dirt road crossing stream	Stream ford over southern branch Waikoloa Stream downstream of Old Rock Wall	Mauna Kea Plantation Estates	Low	Diversion swale
9PT	Sediment input at dirt road crossing stream	Stream ford over southern branch Waikoloa Stream upstream of Old Rock Wall	State of Hawaii	Low	Diversion swale and road BMPs
10PL	Degraded channel, sedimentation/erosion from cattle	Southern branch Waikoloa Stream above confluence with Keanu'i'omanō Stream	State of Hawaii	Low	Fencing
11PL	Degraded channel, sedimentation/erosion from cattle	Middle branch Waikoloa Stream above confluence with Keanu'i'omanō Stream	State of Hawaii	Low	Fencing
12PT	Sediment input at dirt road crossing stream	Confluence of Waikoloa and Keanu'i'omanō Streams	State of Hawaii	Low	Diversion swale and road BMPs
13PG	Cut fill pile with coarse and fine materials migrating into Waikoloa Stream	Waikoloa Stream DHHL Land Lalamilo Phase 2	State of Hawaii - DHHL	High	Stabilize pile; drainage

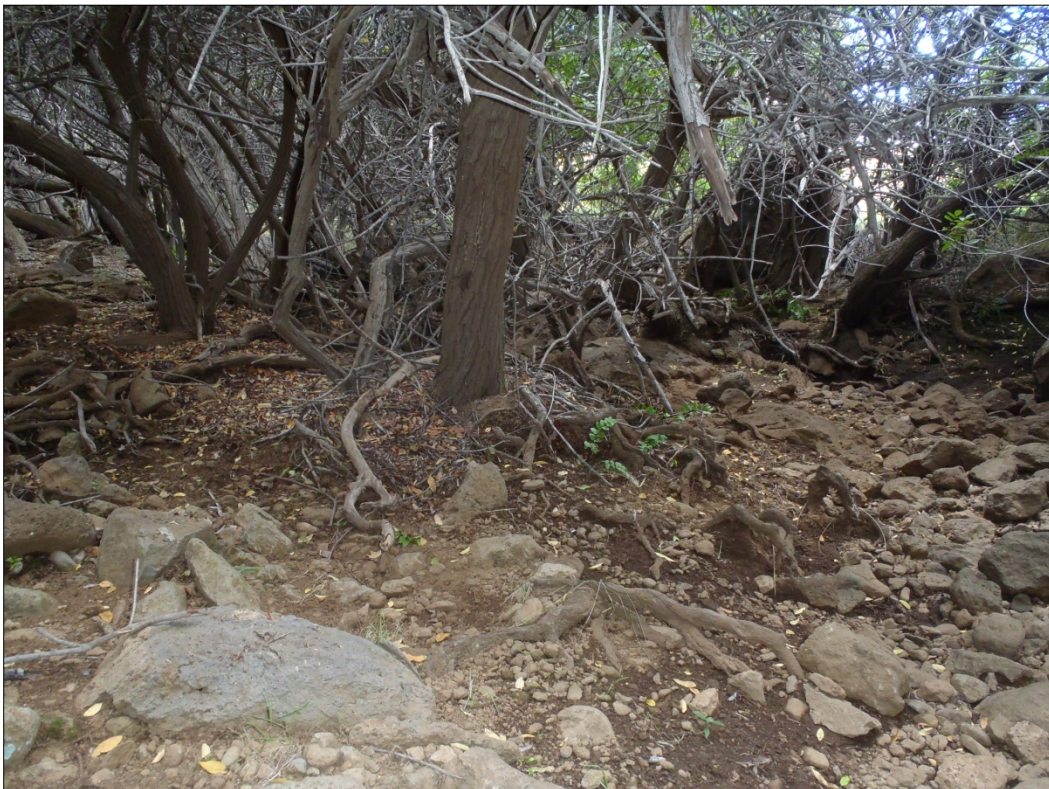
**Photo 8. 10PL & 11PL, General Landscape Image**

Channel on Waikoloa Stream branch, typical of accessible stream areas where cattle bed.

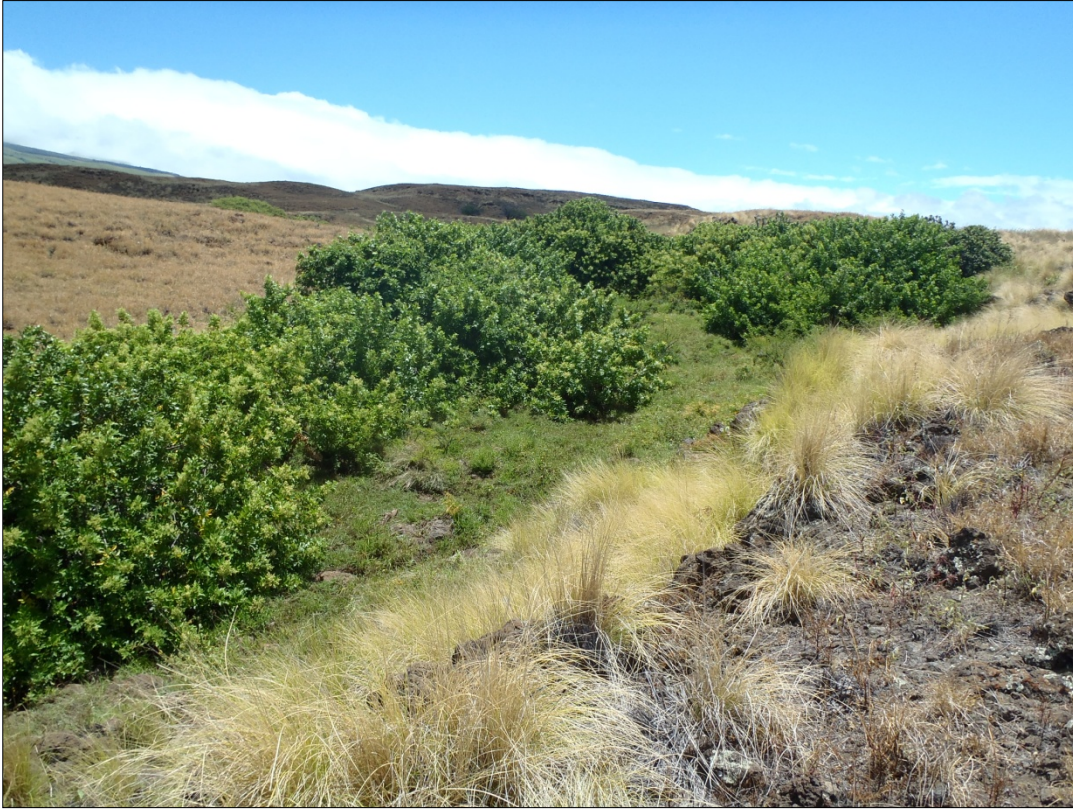
**Photo 9. 16PG, Typical Stream**

Representative image of stream zone within trees, varying degree of stream channel damage

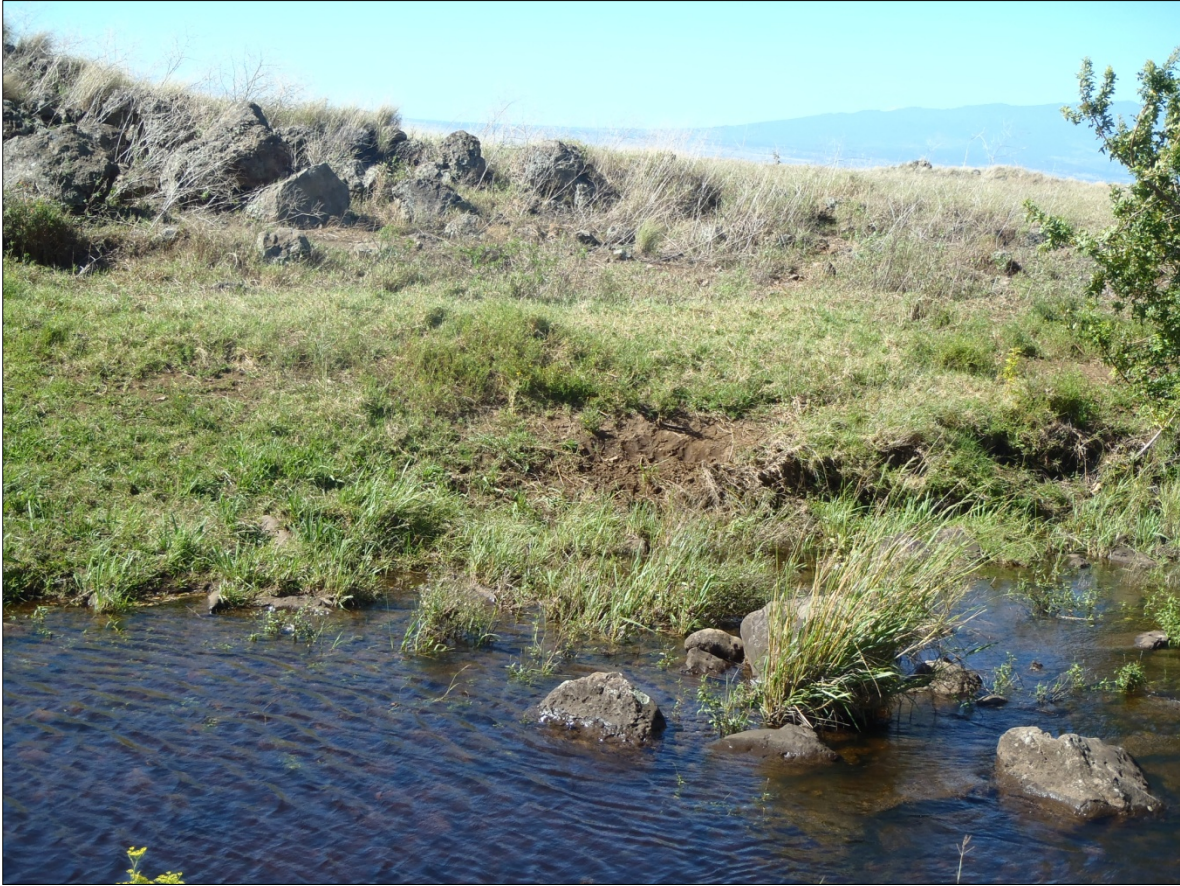
**Photo 11. 15PT, Bank Damage**

Keanu'i'omanō Stream access point by cattle at perennial pool

Site ID	Issue	Location	Land Owner	Priority	Management Measures
15PT	Stream bank trampled by cattle	Keanu'i'omanō Stream at Ouli Gulch	State of Hawaii	Medium	Fencing, bioengineering, install water trough for cattle
16PG	Stream damage by cattle	Waikoloa Stream downstream of DHHL-State parcel	State of Hawaii	Low	Fencing, bioengineering
17PG	Erosion of steep exposed slope above Lanikepu Gulch	Lanikepu Gulch west of HPA	Parker Ranch	Medium	Bioengineering
18PT	Erosion of channel at culvert outfall	Lanikepu Gulch at Kohala Mountain Road	UK	Low	Outfall protection/energy dissipater
19PG	Sediment runoff into stream	Waikoloa Stream at UH Lalamilo Farm	State of Hawaii	Medium	Sediment buffer, bioengineering, grade adjustment
20PL	Sediment discharge off access road along margin of crop field	Waikoloa Stream, Lalamilo Farm Lots	UK	Low	Bioengineering, sediment buffer
21PL	Eroding and unstable stream bank in paddock	Keanu'i'omanō Stream at junction of Kawaihae Road and Kohala Mountain Road	UK	Medium	Fencing, revegetate exposed banks

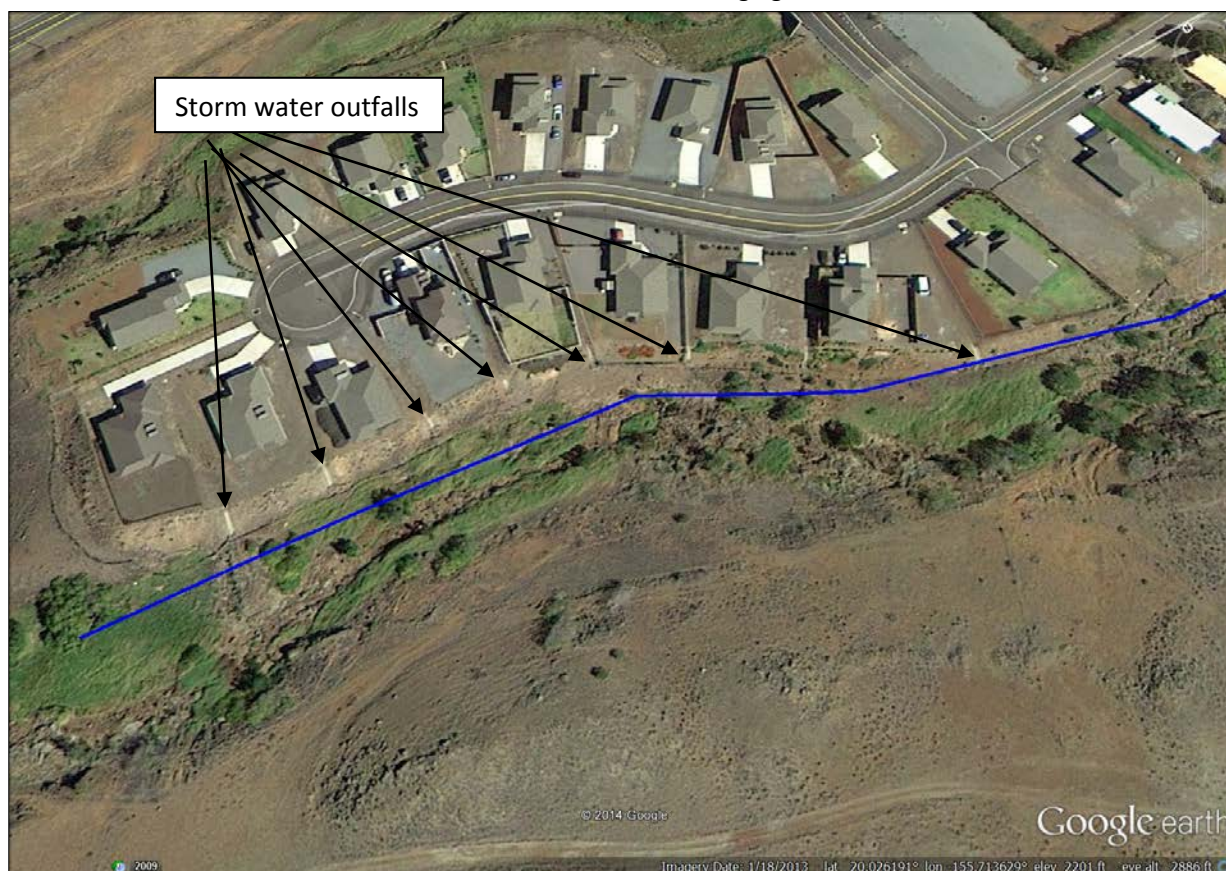
**Photo 13. 29PT, Storm Water Outfalls**

Waiakea subdivision home lots with rock mortar swales discharging onto bank of Keanu'i'omanō Stream

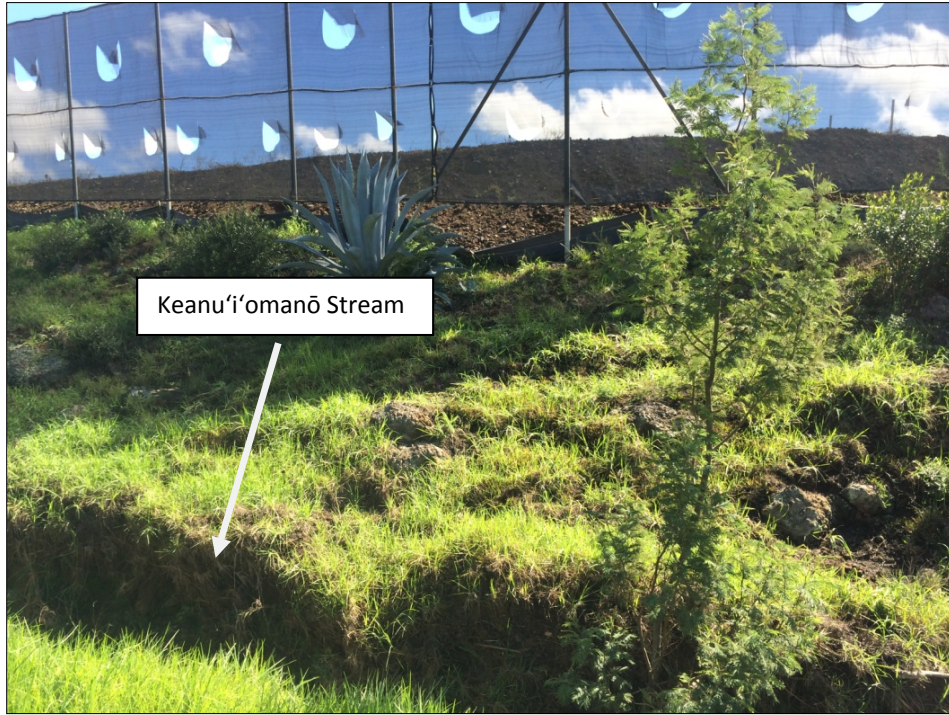
**Photo 15. 24PG, Cut and Fill Piles**

Cut and fill piles spilling onto floodway and stream from State DHHL Lalamilo development

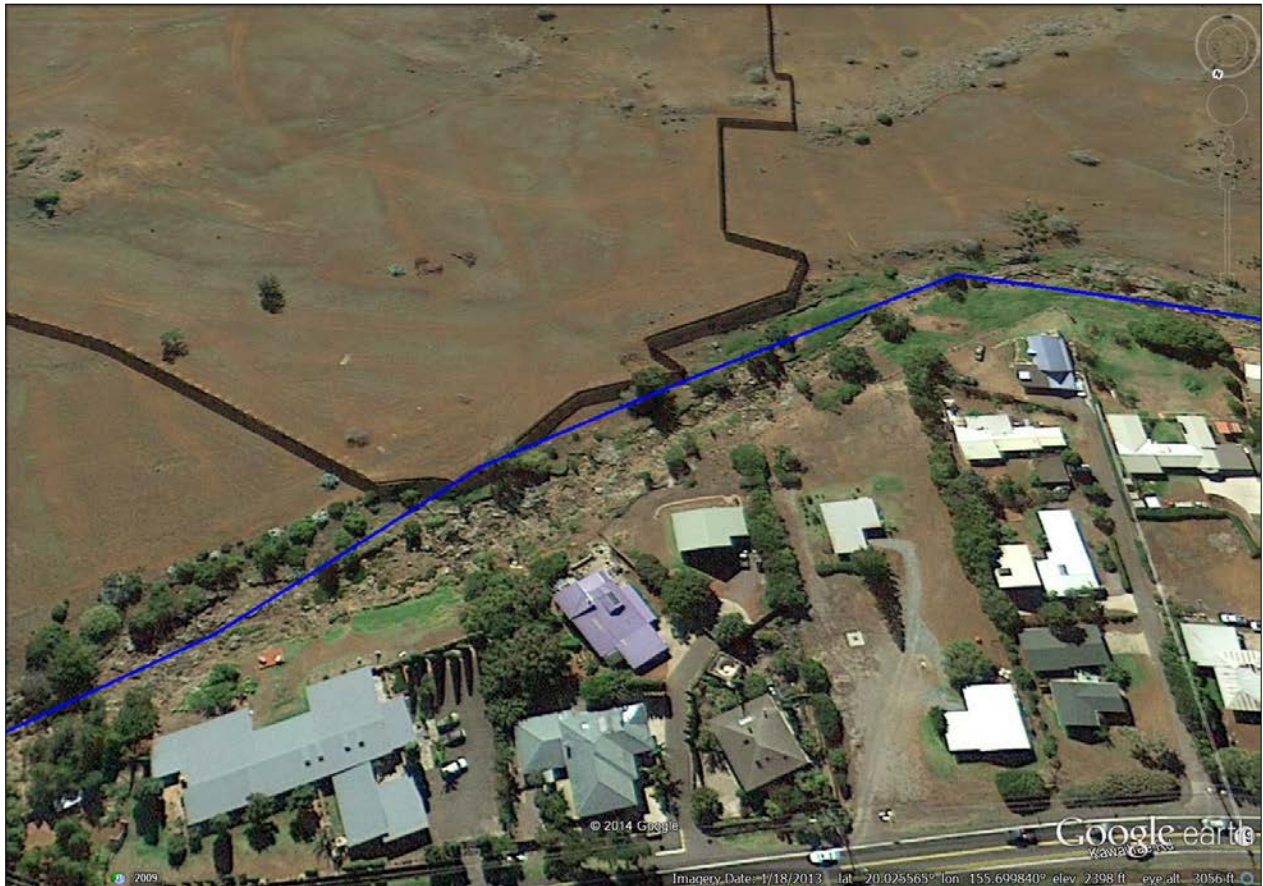
**Photo 16. 24PG, Aerial View of State DHHL Lalamilo Development**

Build out foot print within black fence area appears to encroach onto floodway along Keanu'i'omanō Stream

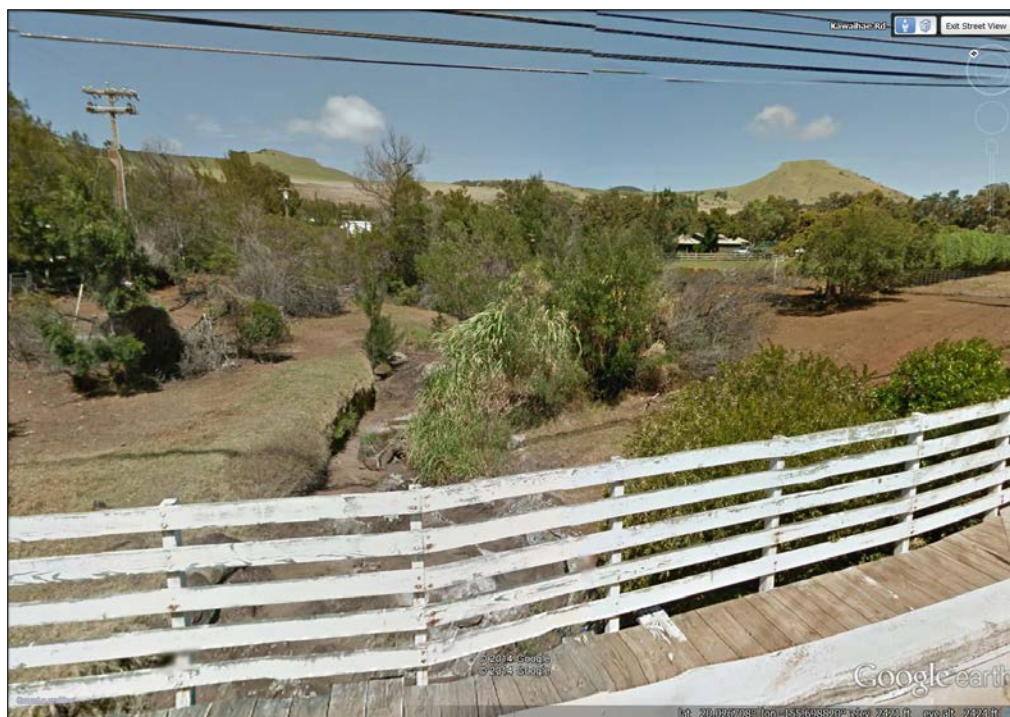
**Photo 18. 21PL, Keanu'i'omanō Stream**

Erosion and unstable bank of stream, zone used for pasture

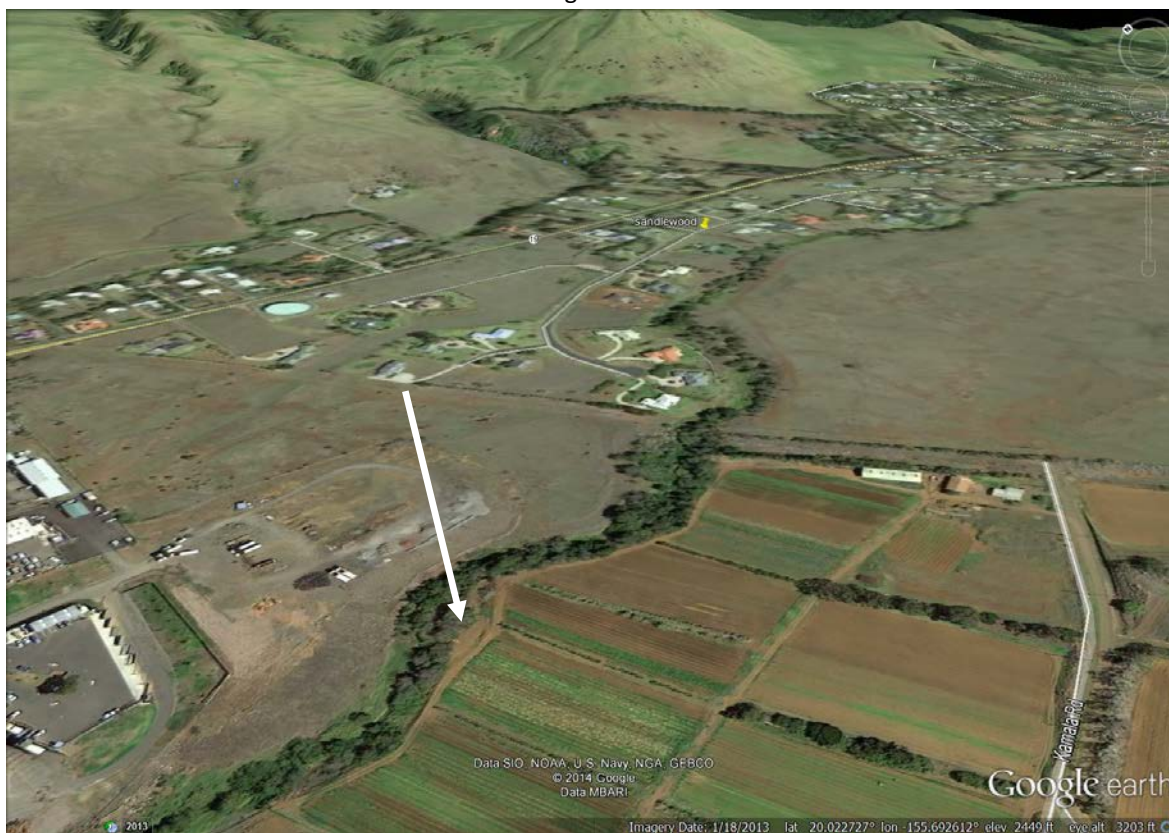
**Photo 19. 20PL, Lalamilo Farm**

Narrow buffer between edge of field and Waikoloa Stream

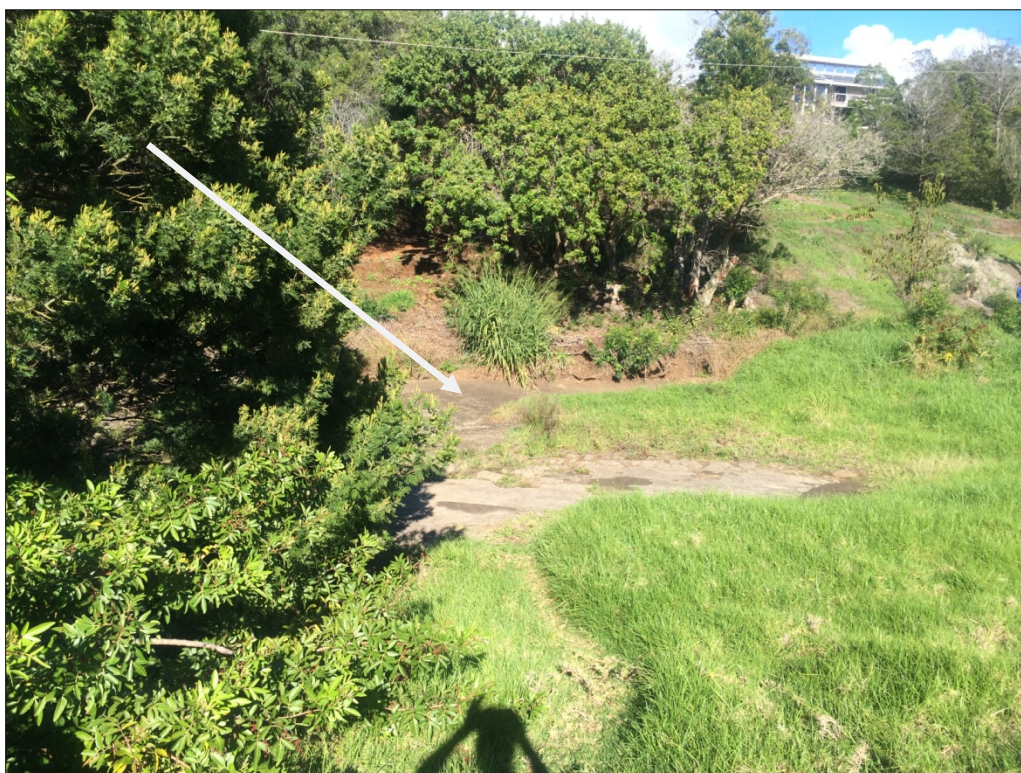
**Photo 20. 30PT, Waikoloa Stream - old stream ford**

Concrete ford instream creates possible fish barrier. Erosion and sediment input for approach roads into stream.

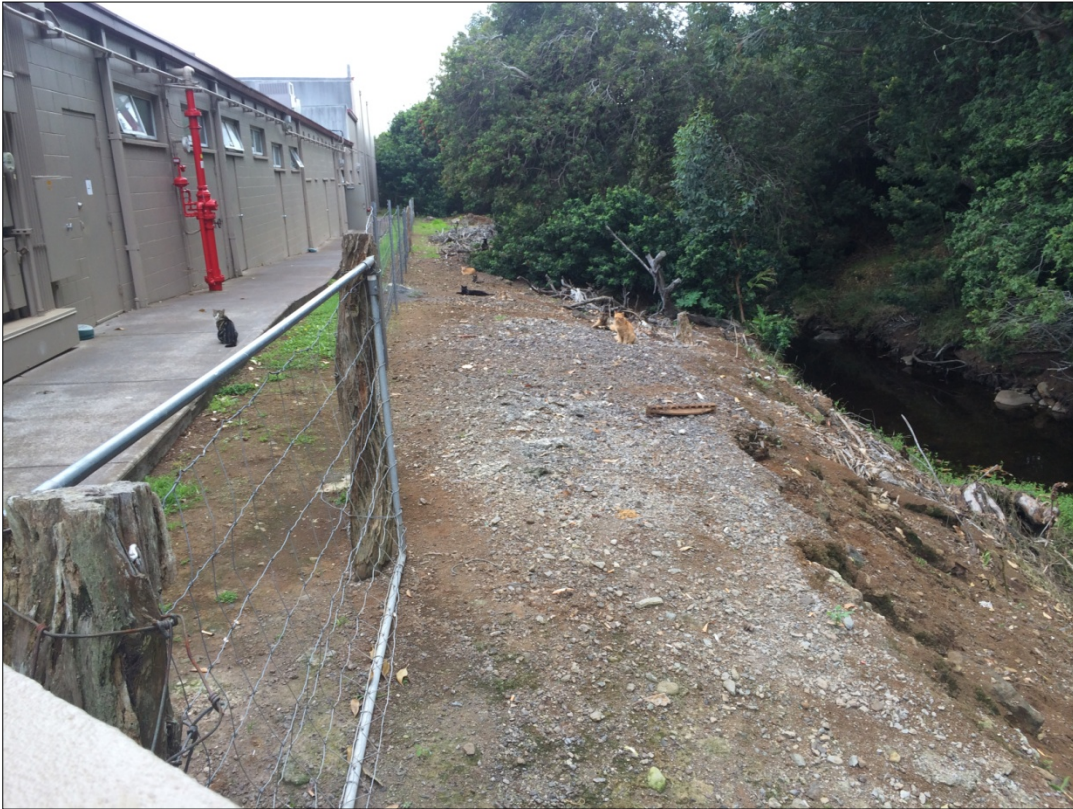
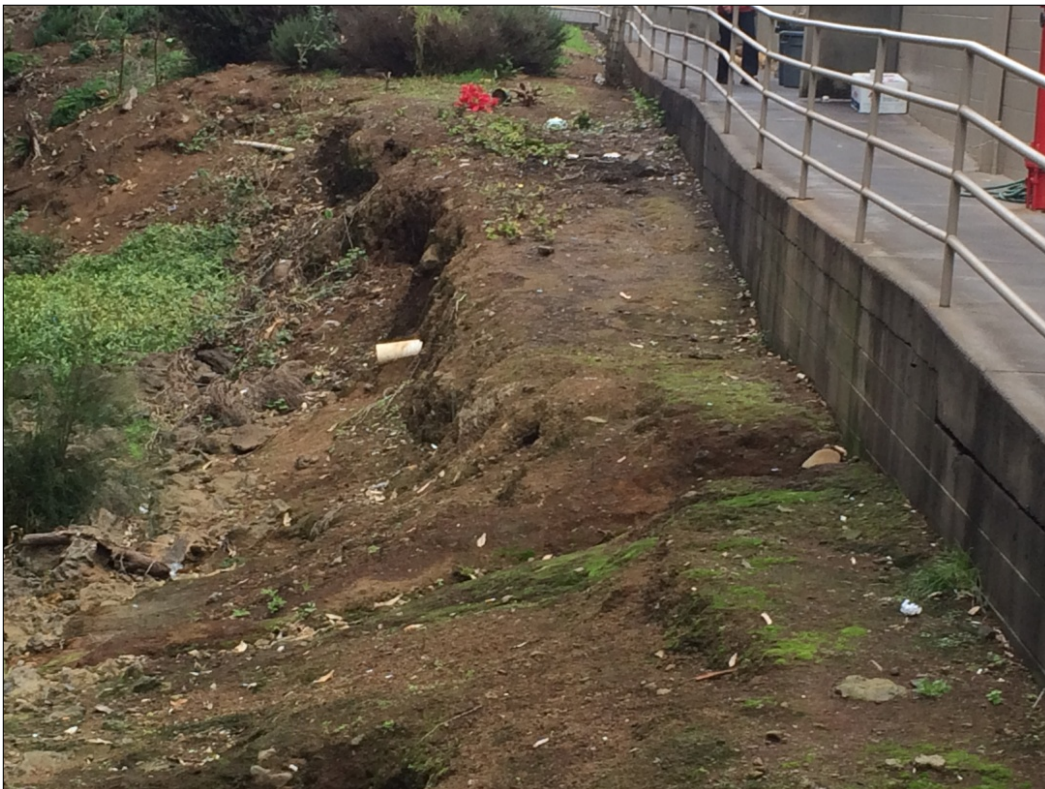
**Photo 23. 23PG, Waikoloa Stream - Waimea Shopping Center**

Multiple issues: degraded banks eroding, illicit discharge onto stream banks, feral cat colonies, bacteria loading into water, bare banks, parking lot runoff into stream.
